Sediment Issues for the Bryson Project

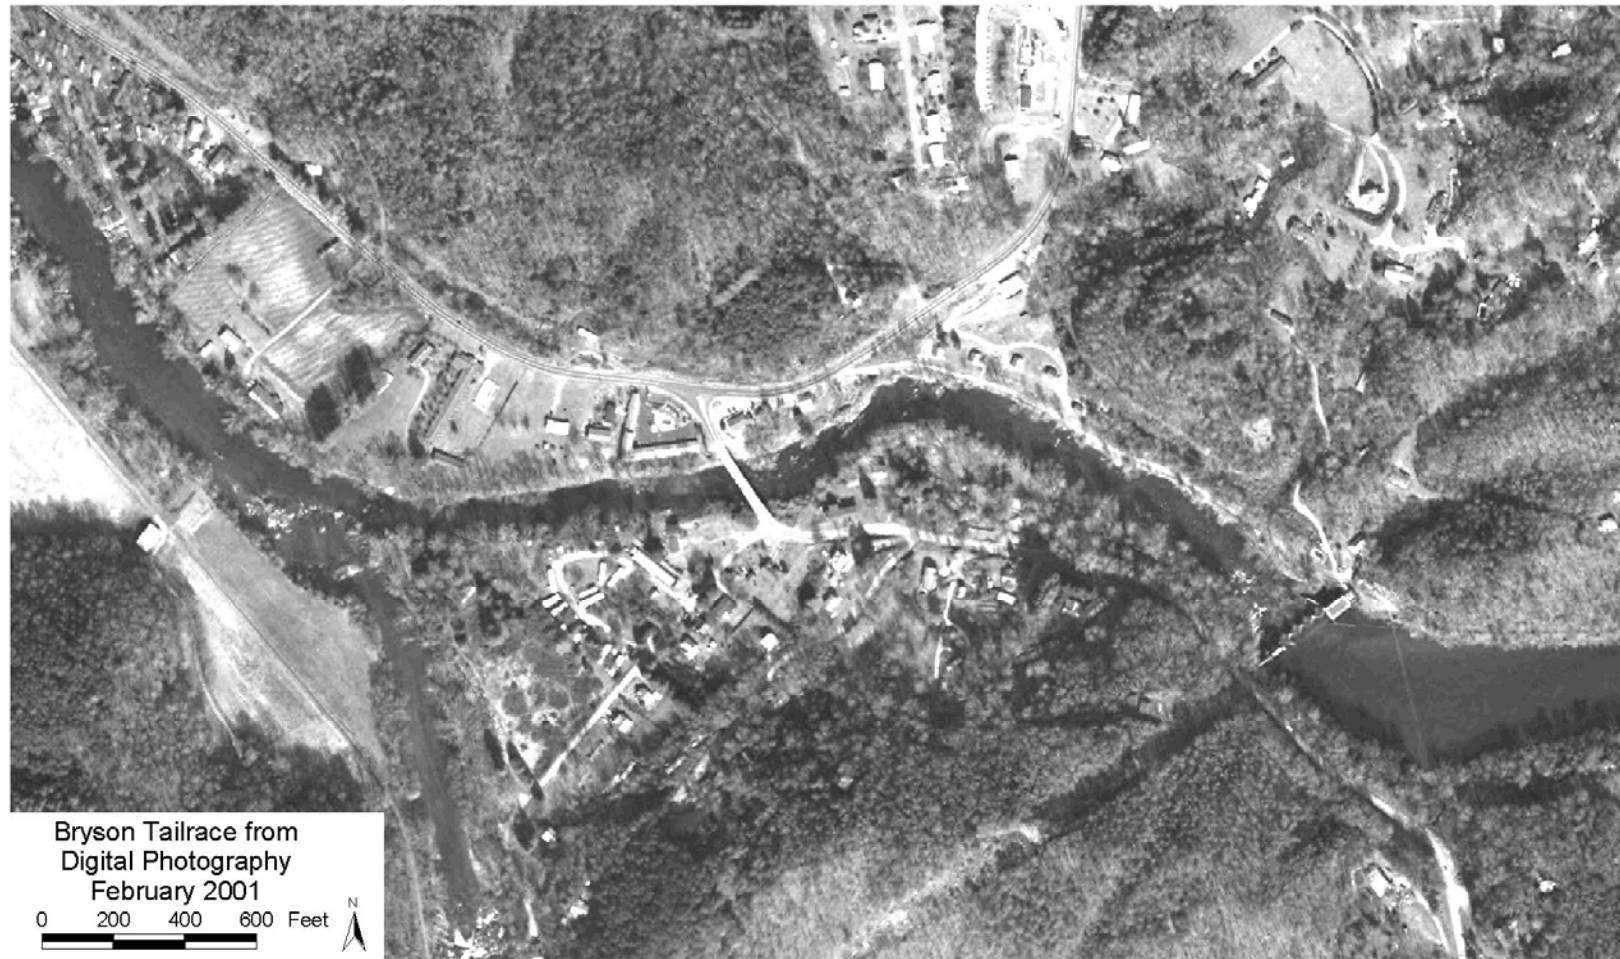
There is no delta formation (i.e., indicating excessive sediment availability) downstream of Bryson dam. There appears to be a balance between sediment delivered to this area and the ability of the river to move this material (US Army Corps of Engineers 1997).

Bryson Tailrace from
Digital Photography
February 2001
