Sediment Issues for the Franklin Project

Bathymetric Surveys

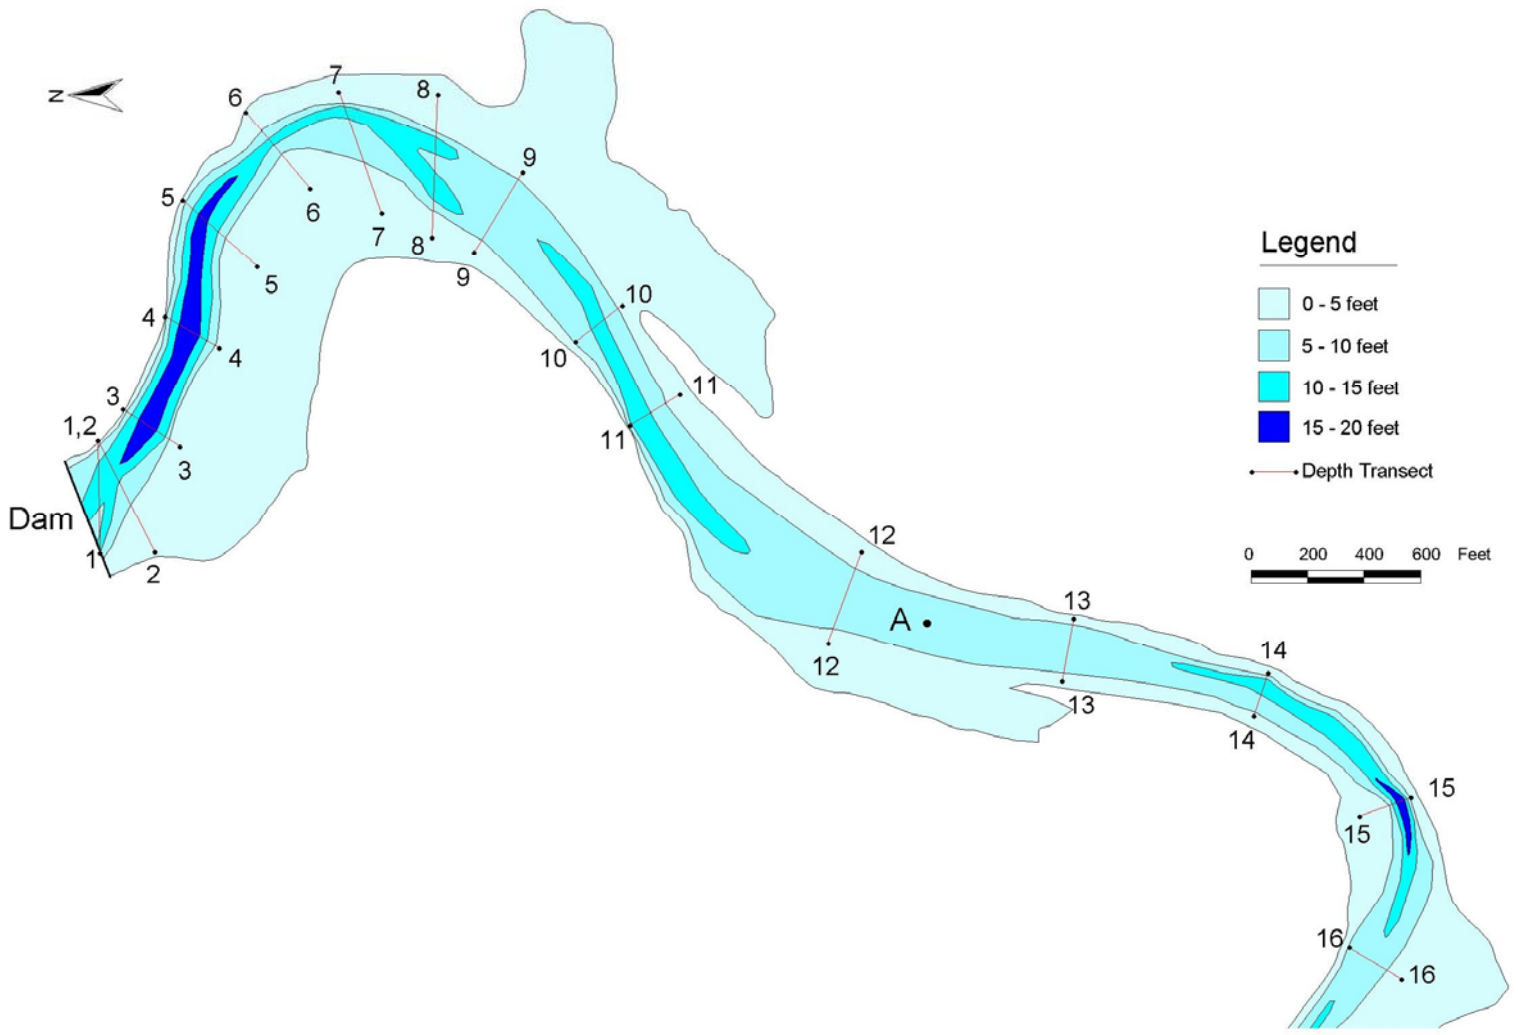
The bathymetry and particle size data show that the reservoir is similar to a river with a sandy-silt bed (Figure 5.3.7-1). Sediment translocation within and transport through the reservoir are dependent on the river flows. During periods of lower flows (roughly less than half bankfull) there is sediment deposition, and during high flows (roughly bankfull or greater) there is sediment mobilization and transport through and out of the reservoir.

Table 5.3.7-1. Franklin Project. Percentage of sediments passed through nested standard sieves. Locations designated by capital letters correspond to locations in Figure 5.3.7-1. Results are represented with RIGHT as the right-hand side facing the dam.

The results of the July 2001 bathymetry survey compared to the 1999 depth profiles reveal no major changes. Comparisons of the maps yield little information regarding changes in the storage volume of the reservoir and give no useable information about the rate of sediment accumulation.

Sediment carried by the Little Tennessee River is highly mobile and composed of suspended sands and silts which are deposited on the falling limb of the hydrograph in backwater areas, but easily re-suspended and moved during high flow events. Based on the bathymetric maps, the general form of the channel bed upstream of the dam remained unchanged. Material deposited behind the dam is very fine grained (generally less than 1 mm) and is of such a composition that it is easily re-suspended during high flows. There is no decrease in particle size from upstream to downstream near the dam, which would have indicated coarse particles aggrading due to backwater effects of the dam. Particle sizes along the length of the reservoir indicate that deeper areas have 1 mm particles, and shallower areas have essentially very fine, suspendable particles less than 0.1 mm (see A through D Figure 5.3.7-1 and Table 5.3.7-1). During high flows observations upstream and downstream of the dam indicated the presence of large amounts of suspended materials; as flows dropped, this material was not stored in the main channel except for in backwaters and deep pools.

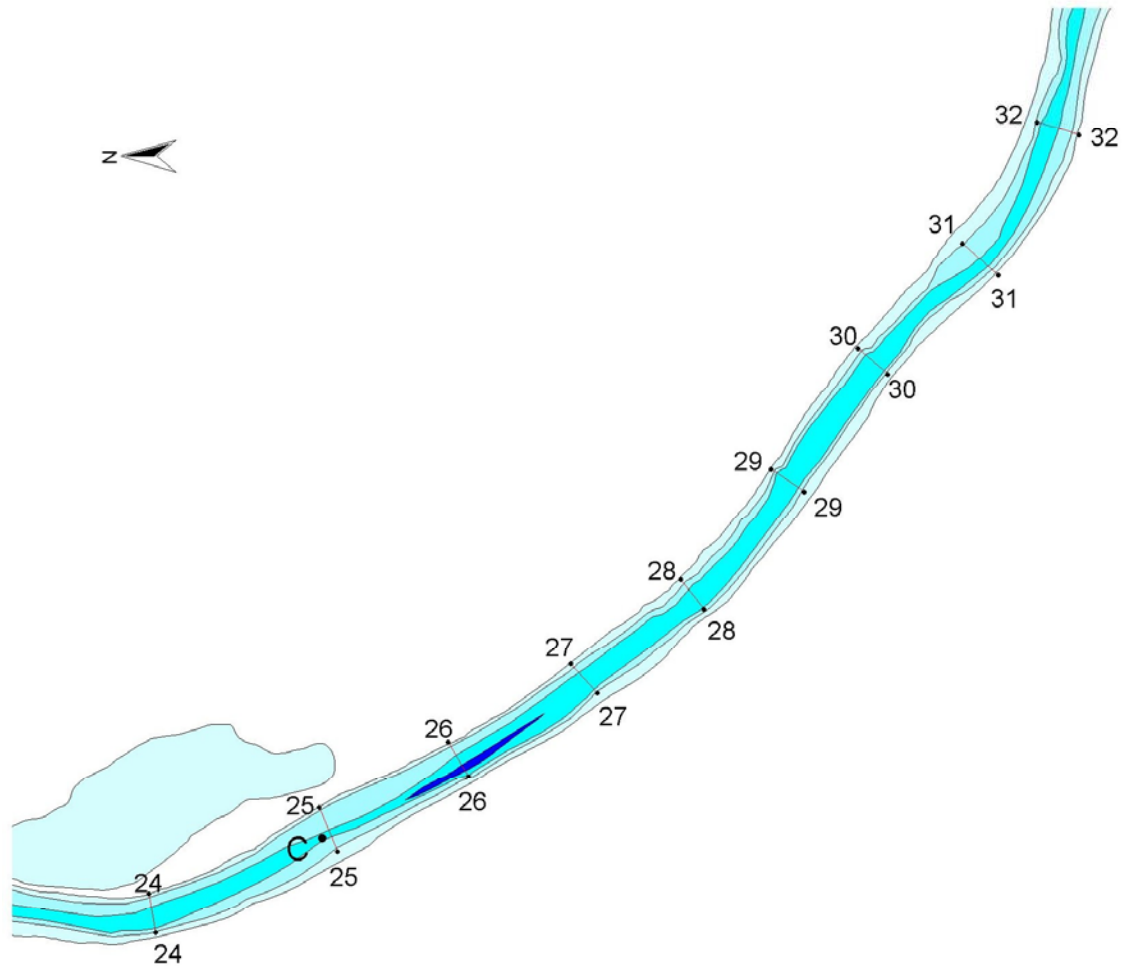
- 0 - 5 feet
- 5 - 10 feet
- 10 - 15 feet
- 15 - 20 feet
- Depth Transect

Bathymetric surveys were conducted in June 2001. Measurements were taken along transects used to produce the 1999 maps (Nantahala Power and Light 2000). An aluminum boat equipped with an outboard motor and an electric trolling motor was used to obtain depth readings using a depth finder with an accuracy of +/- 0.5 ft. The shoreline points used in the 1999 survey were used to establish transects used in the 2001 survey. To locate each transect, a Trimble model AgGPS 132, with sub-meter differential accuracy (correction factors from Omnistar Satellite service) was used to establish GPS points established as close to the right-hand bank left-hand bank (facing downstream) as possible. At some locations the GPS points were established a considerable distance from the shore due to a lack of signal availability because of overhanging trees. Here, the GPS points were located on the map (e.g. transect 10 in Figure 5.3.7-1) and depths recorded along regular intervals to the shore. A field estimate was made as to the distance to the bank; a more accurate distance measure was made using the Arc-View (version 3.2a) measuring tool on the aerial imagery. The image was geo-referenced and has a 3-ft

resolution. The bathymetric map was produced by transferring the GPS points, transects, and depth data to the aerial image.
