Sediment Issues for the Tuckasegee Project

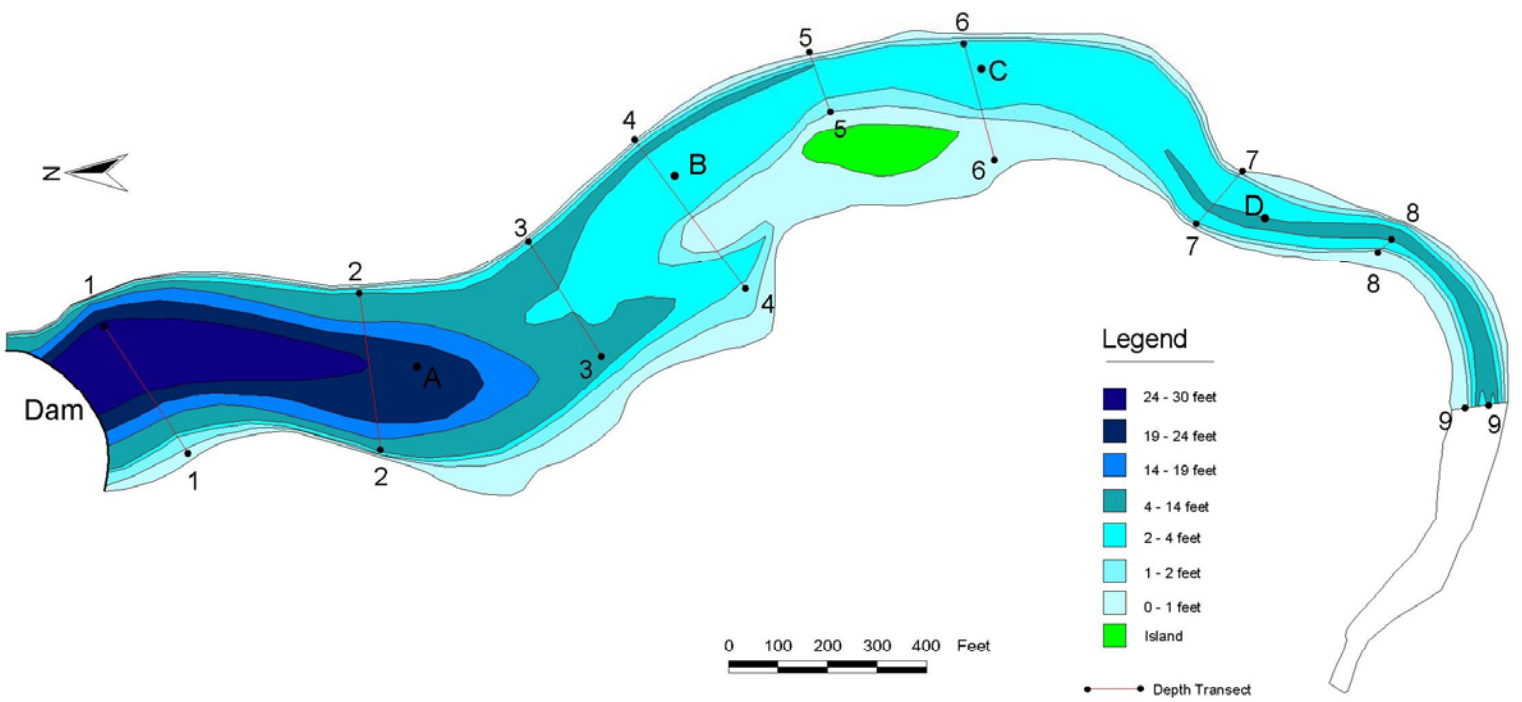
Bathymetric surveys were started in June and completed August 2001. Measurements were taken along transects used to produce the 1999 maps. An aluminum boat equipped with an outboard motor and an electric trolling motor was used to obtain depth readings using a depth finder with an accuracy of +/- 0.5 ft. The shoreline points used in the 1999 survey were used to establish transects for the 2001 survey. For each transect a GPS point, using a Trimble model AgGPS 132, with sub-meter differential accuracy (correction factors from Omnistar Satellite service) was established as close to the right-hand bank (facing downstream) as possible and another GPS point was established as close as possible to the left-hand bank. At some locations the GPS points were established a considerable distance from the shore due to a lack of signal because of overhanging trees. Here the GPS points were located on the map (for instance transect 5 in Figure 5.3.7-1) and depths recorded along regular intervals to the shore. At other

locations the GPS point was recorded at an area where the water depth was less than 2 feet and not accessible by boat. A field estimate was made as to the distance to the bank; a more accurate distance measure was made using the Arc-View (version 3.2a) measuring tool on the aerial imagery. The image was geo-referenced and has a 3 foot resolution. The bathymetric map was produced by transferring the GPS points, transects, and depth data to the aerial image.

Table 5.3.7-1. Tuckaseegee Project. Percentage of sediments passed through nested standard sieves. Locations designated by capital letters correspond to locations in Figure 5.3.7-1. Results are represented with RIGHT as the right-hand side facing the dam
