Sediment Issues for the Mission Project

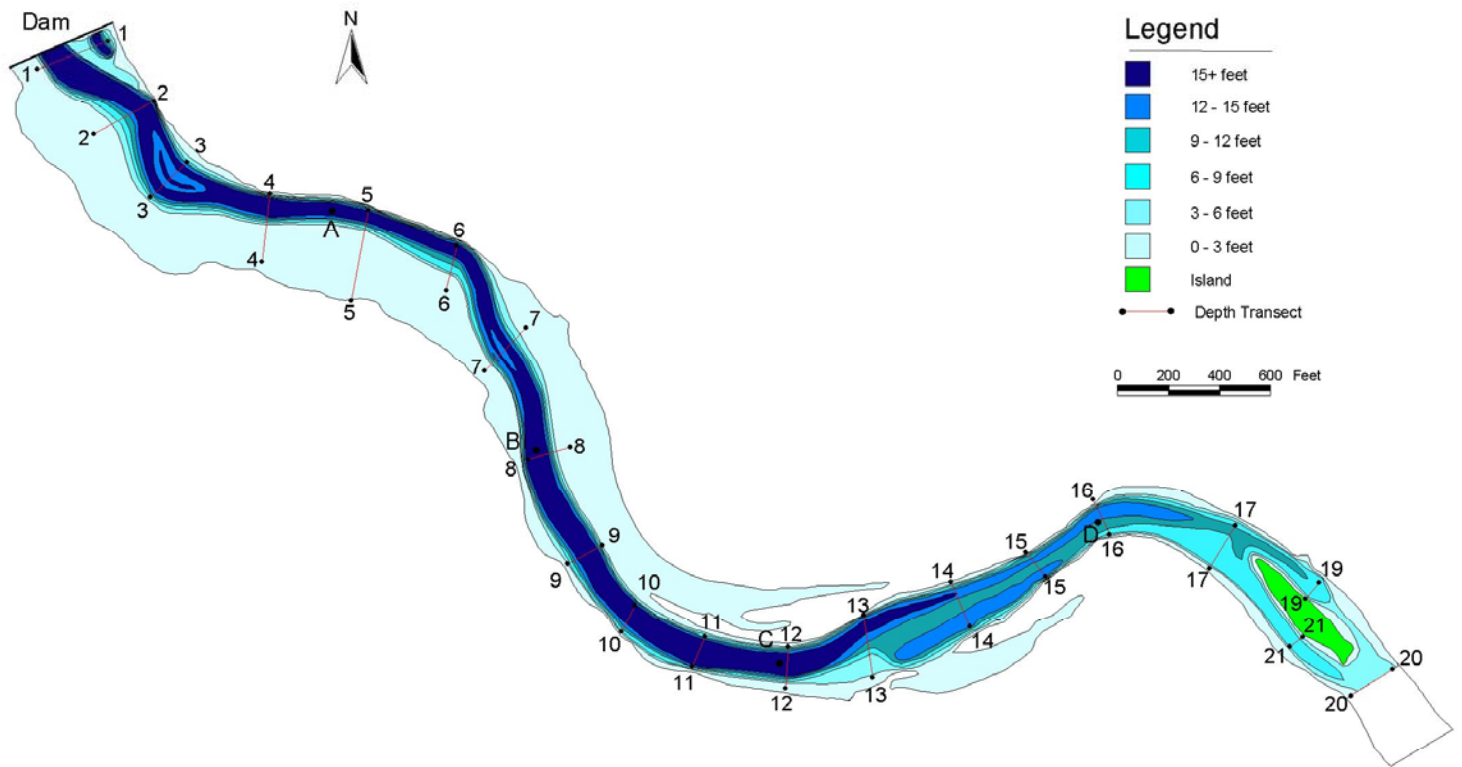
Dam

- 15+ feet
- 12 - 15 feet
- 9 - 12 feet
- 6 - 9 feet
- 3 - 6 feet
- 0 - 3 feet
- Island
- Depth Transect

0 200 400 600 Feet

Bathymetric surveys were conducted in August 2001; no bathymetric maps were done in 1999. Measurements were taken along transects as indicated in Figure 5.3.7-1. An aluminum boat equipped with an outboard motor and an electric trolling motor was used to obtain depth readings using a depth finder with an accuracy of +/- 0.1 ft. To locate each transect, a Trimble model AgGPS 132, with sub-meter differential accuracy (correction factors from Omnistar Satellite service) was used to establish GPS points established as close to the right-hand bank left-hand bank (facing downstream) as possible. In some cases the GPS points were established between the shore and mid-channel because the tree canopy near the banks interfered with satellite signal reception. In these cases the GPS points are located on the map (for instance transect 6 in Figure 5.3.7-1) and depths placed along regular intervals to the shore. In other cases the GPS point was recorded at an area where the water depth was less than 2 ft and not accessible

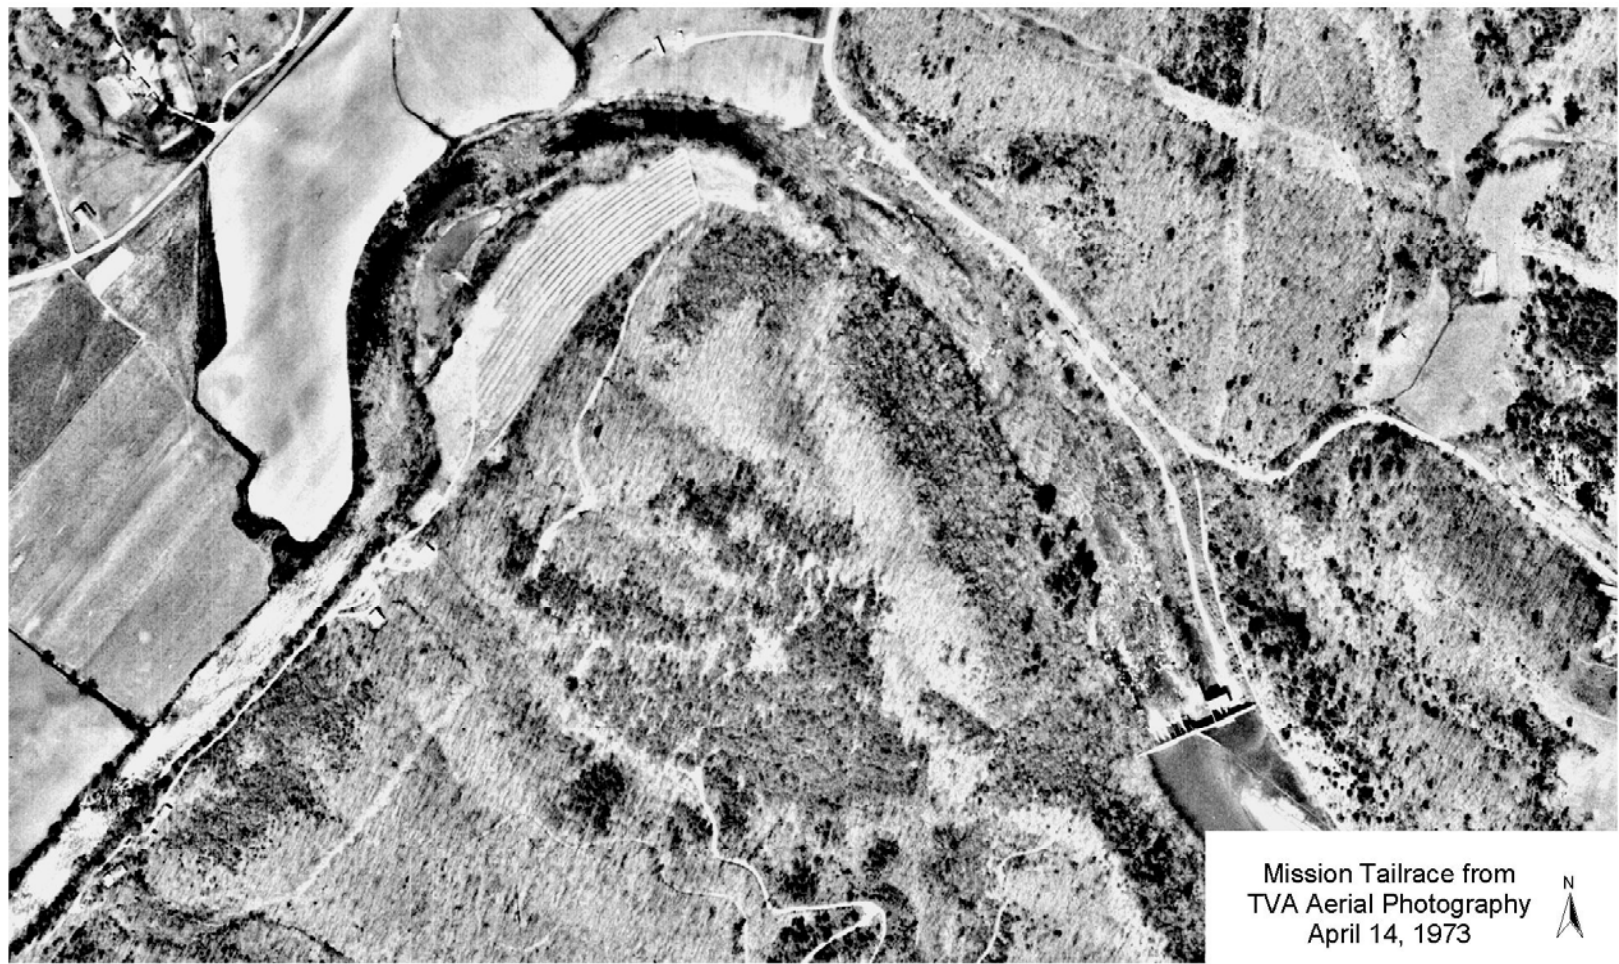
Mission Tailrace from
TVA Aerial Photography
April 14, 1973
