**CONSIDERATIONS FOR LOCATING A WATER QUALITY
MONITOR IN THE TAILWATER OF WYLIE DAM**

Prepared by
Reservoir Environmental Management, Inc
Richard J. Ruane, Andrew F Sawyer, Phil Clapp

Prepared for
Duke Power Company
Jon Knight, Steve Gaffney

February 24, 2003

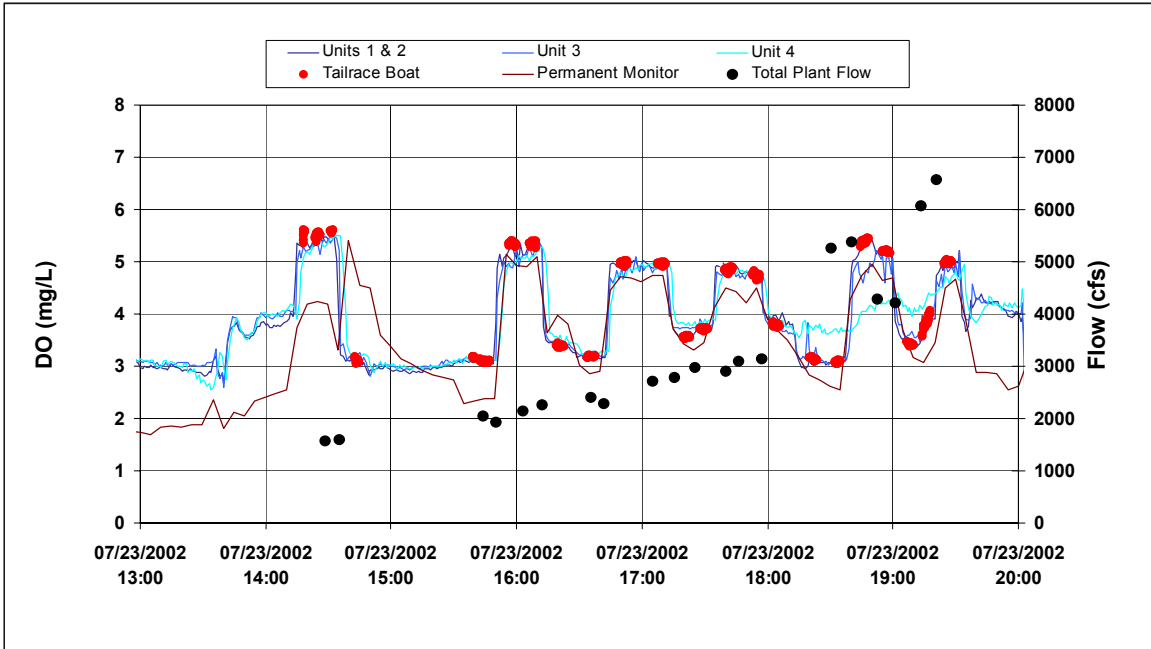
Figure 2: Tailrace DO Measurements During Tests On Unit 1 (plus Unit 4 after 18:00), July 23, 2002

Evaluation of the current monitor location. Figures 2 through 5 present comparisons between the readings from the various monitors in the tailrace during the turbine testing. These figures show that readings by the permanent monitor were usually 0.5 to 2 mg/L lower than DO values measured directly downstream from the units, even for the DO in the discharge from Unit 1. The error usually was greatest when the air supply valves were open on Unit 3 and the highest DO levels were measured in the tailrace. Thus, the current monitor significantly under-represents the higher DO conditions in the tailrace when Unit 3 is aerated. While there are obvious advantages for the current location (considering the above criteria items 2, 3, 4, 6, and 7), the monitor needs to be moved to another spot that better complies with the location criteria listed above.

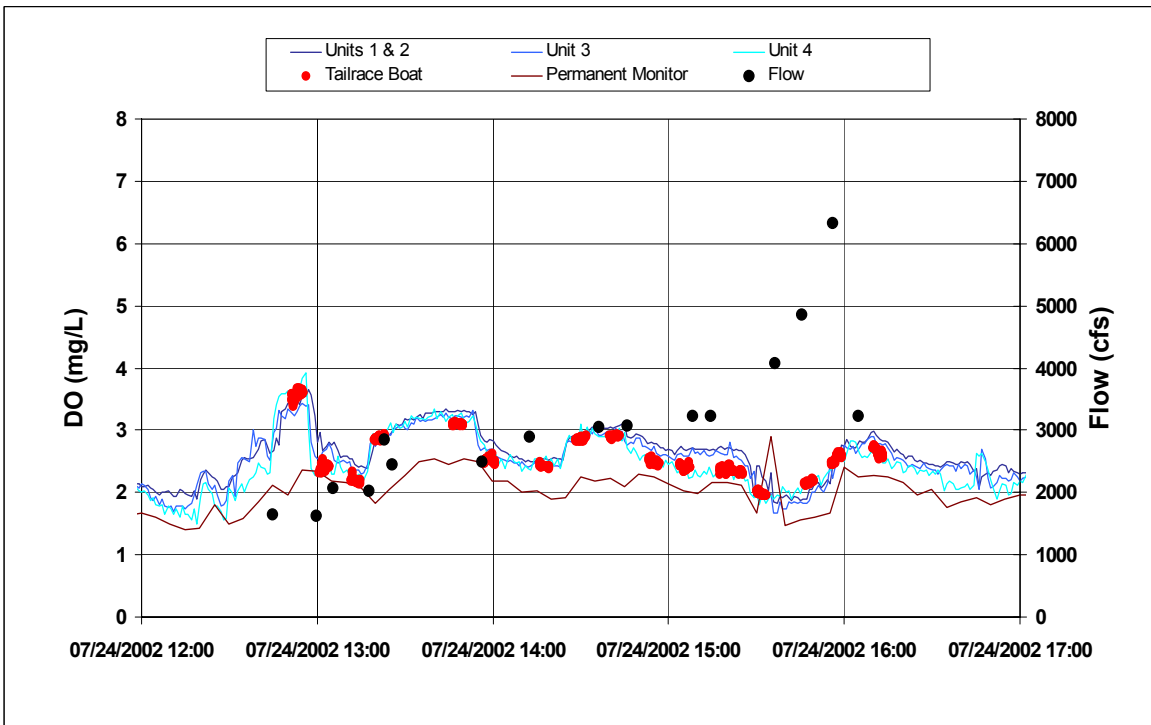
Figure 3: Tailrace DO Measurements During Tests On Unit 4 (plus Unit 1 after 15:30), July 24, 2002

Although the water does not completely mix within the first mile as it passes down the river, it is important to note that under high flow conditions (three- or four-unit operation) the DO in the discharge from Unit 4 is not as low as it is when only one or two units are operated (see Figure 3 which shows DO between 2 and 3 mg/L when only Unit 4 or Units 1 and 4 were operating.) Hence, the concern about mixing does not appear to be as significant when three or four units are operating, especially if air is aspirated into the units.

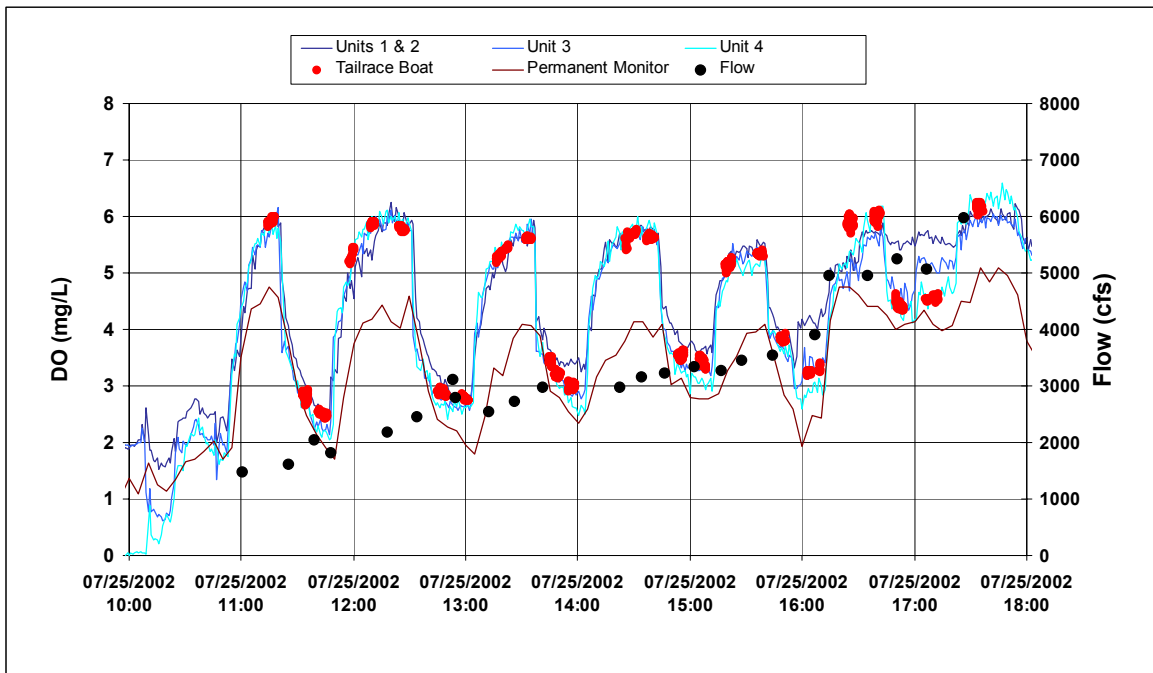
Figure 4: Tailrace DO Measurements During Tests On Unit 3 (plus Unit 1 after 16:00), July 25, 2002

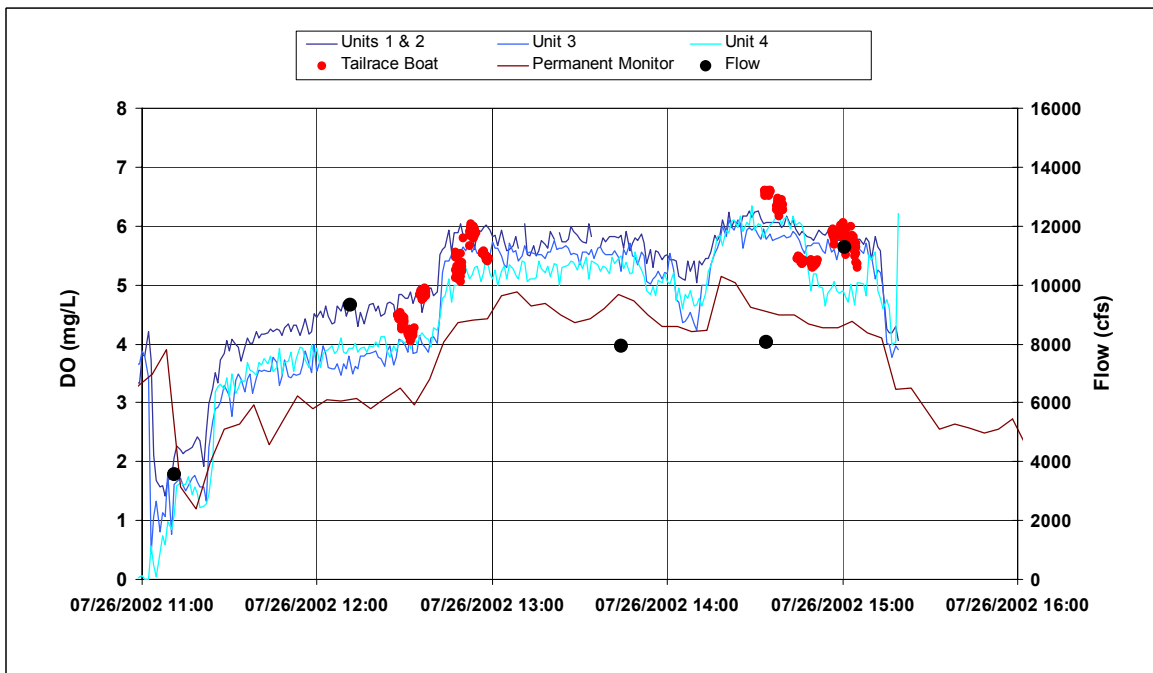
Figure 5: Tailrace DO Measurements During Tests on multiple units, July 26, 2002

Figures 6 through 8 show that the discharges from the different units did not entirely mix even by the time the water reached the transect location downstream from Johnnytown Branch (CRM 140.2), i.e., DO, temperature, and TDG were higher on the left descending side of the river while conductivity was lower. These variations in water quality across the channel were consistent with water quality measured in the discharges from Units 1, 3, and 4, respectively (see Figure 5.)

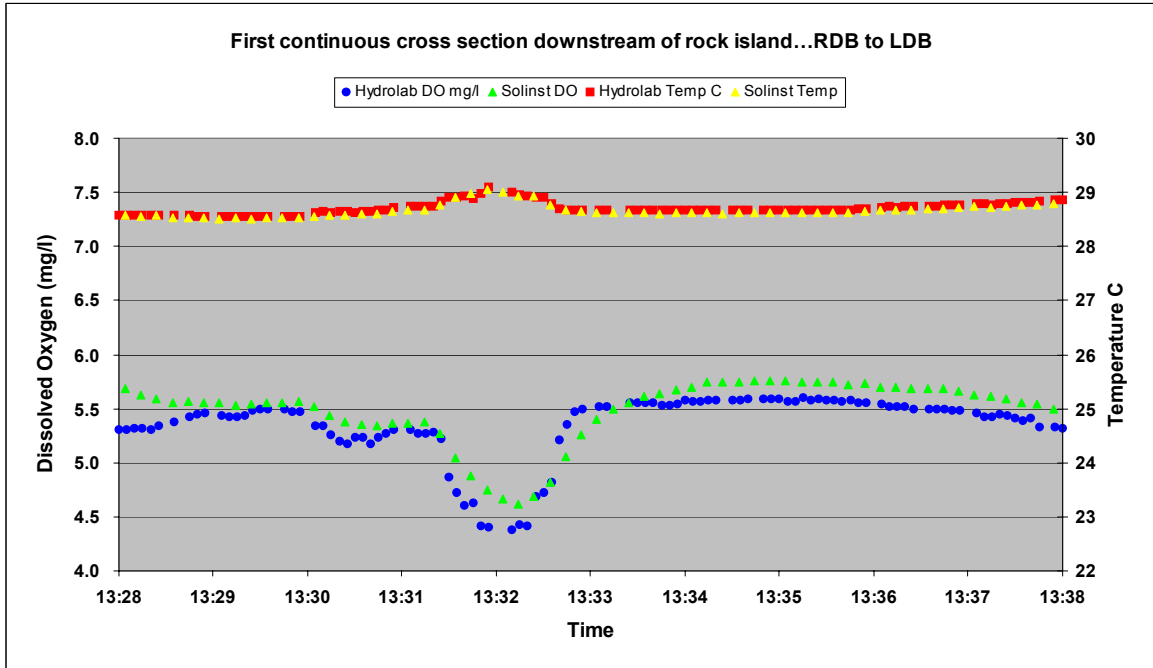
Figure 6: DO and Temperature at Cross Section Downstream of rock island

The water quality variation across the transect located immediately downstream from the rock island was unique compared to the other transects because the water quality at the mid-part of the transect was significantly different. This was caused by a “dead zone” in the area behind the rock island where water did not mix as fast with other water across the transect. The water with lower DO (i.e., about 4.5 mg/L) in the dead zone was the result of previous discharge conditions about an hour earlier when the same three units were operated without air supplied to the units.

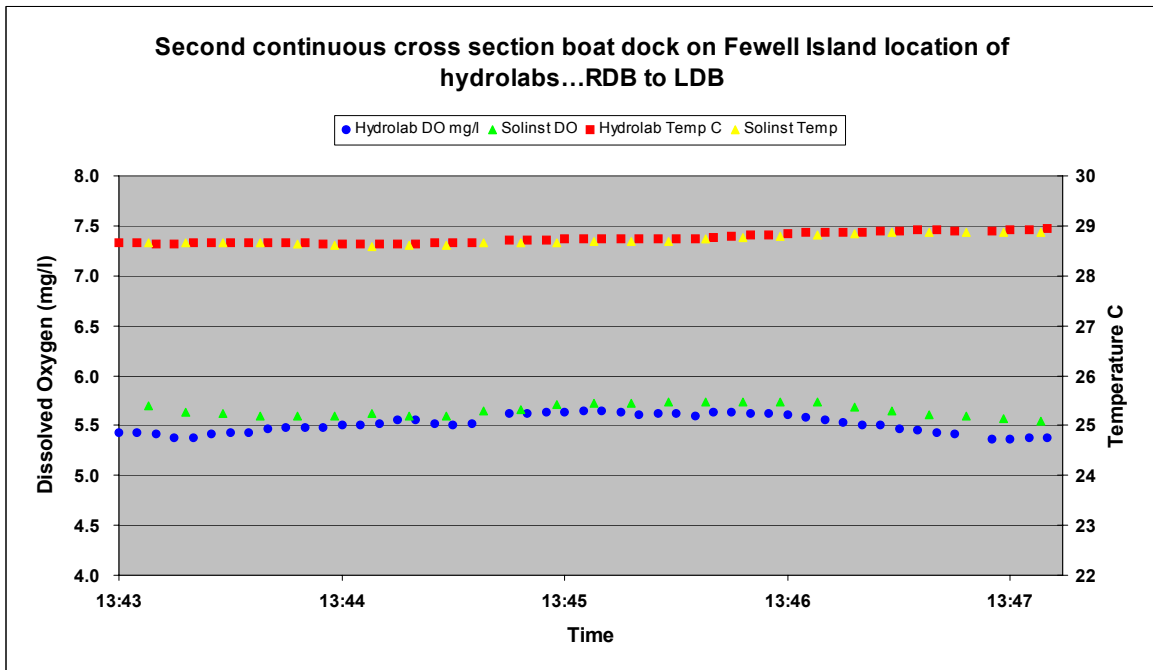
Figure 7: DO and Temperature Near Boat Dock on Fewell Island

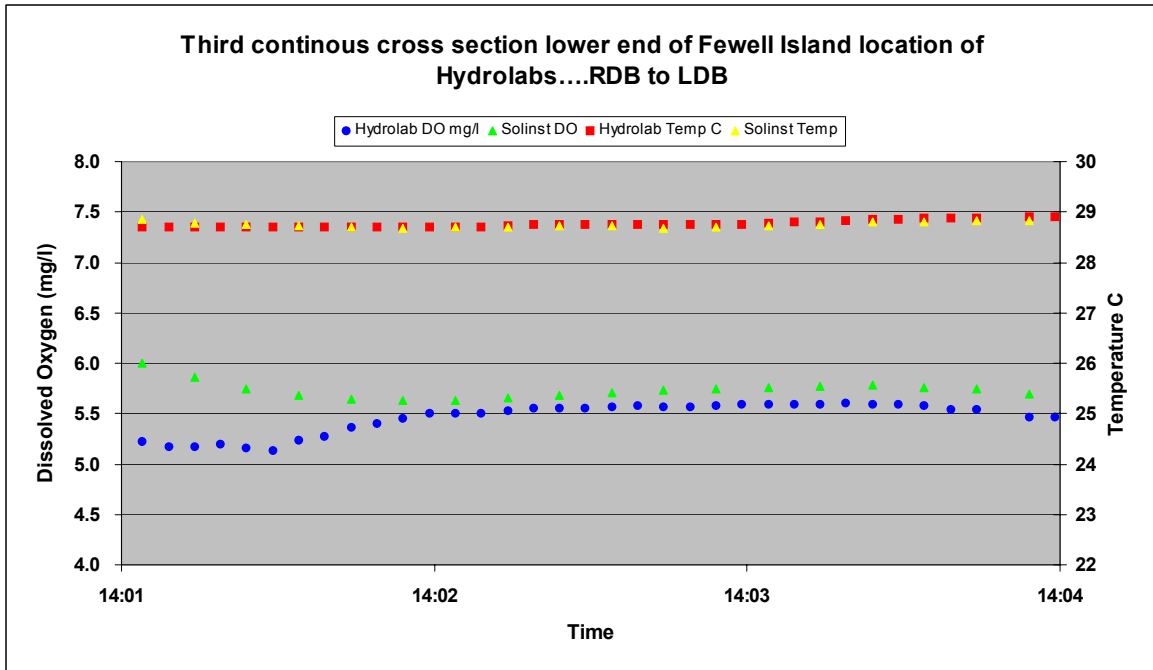
Figure 8: DO and Temperature Lower End of Fewell Island

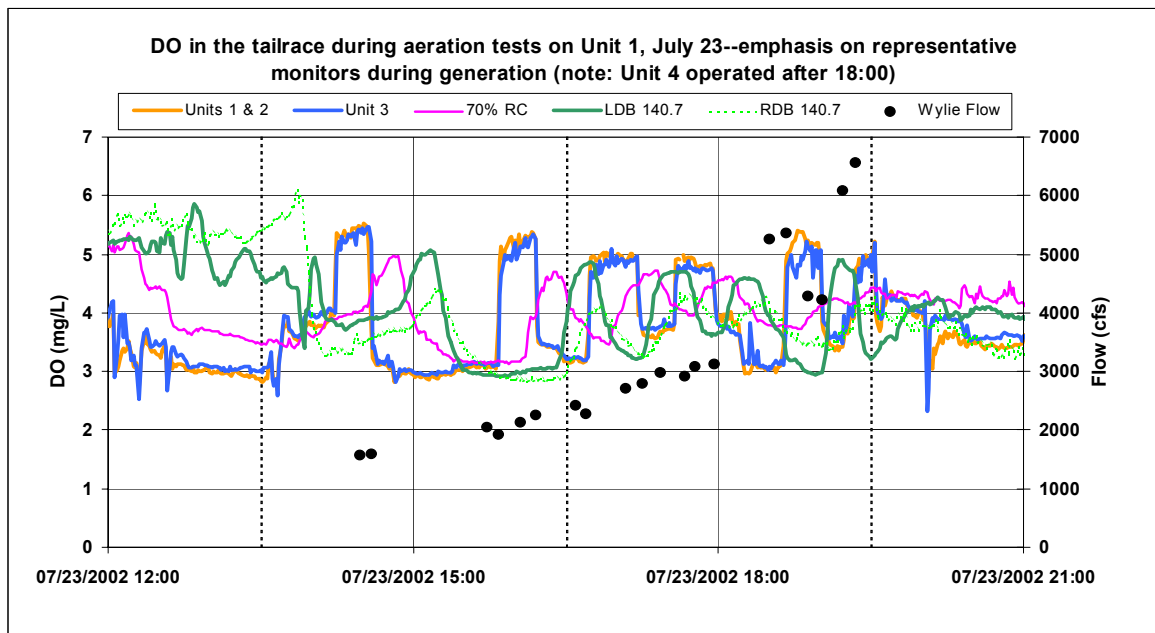
Figure 9: Tailrace DO Measurements, Various Monitors, Unit 1 Tests, July 23, 2002

1. The monitor at RC 70 % was the most responsive during the single unit tests—about a 15-minute response time when Units 1 or 3 were operated at about 80 % gate; however, it did not yield representative results for Unit 1 when Unit 4 was operated near the end of the testing on July 23 (see Figure 9.) It can be assumed that a monitor in the vicinity of RC 70 % would only represent the DO conditions in the discharge from the unit that is operated nearest the RDB. Also, this monitor usually recorded a DO level about 0.2 to 0.5 mg/L less than the DO recorded in the discharge of Unit 1; however, it recorded about the same DO as Unit 3.

3. The next most responsive location was CRM 140.75 RDB—about a 45-minute response time when Units 1 or 3 were operated at about 80 % gate; however, this location did not yield representative results for Unit 1 when Unit 4 was operated near the end of the testing on July 23 (see Figure 9.) It can be assumed that a monitor in the vicinity of CRM 140.75 RDB would only represent the DO conditions in the discharge from the unit that is operated nearest the RDB. Also, this monitor usually recorded a DO level about 0.5 to 1 mg/L less than the DO recorded in the discharge of the units, especially when Unit 1 was operated.

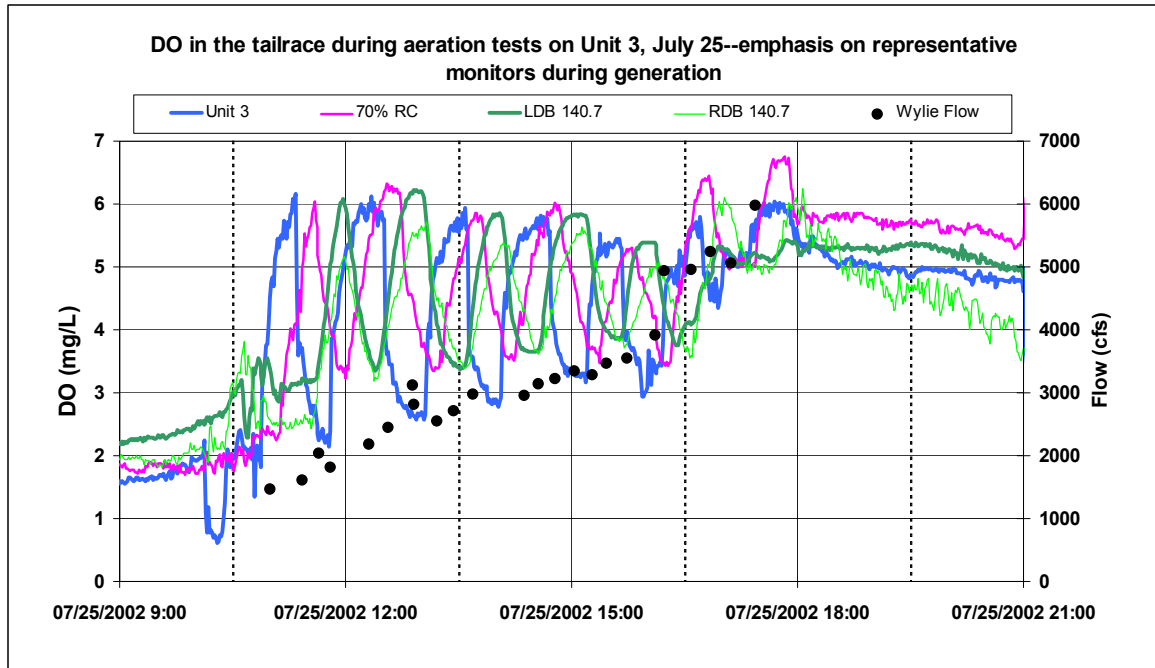
Figure 10: Tailrace DO Measurements, Various Monitors, Unit 3 Tests, July 25, 2002 (note: Unit 1 was operated starting at about 16:00.)

2. The next most responsive location was CRM 140.75 LDB—about a 30-minute response time when Units 1 or 3 were operated at about 80 % gate; however, this location did not yield representative results for Unit 3 when Unit 1 was operated near the end of the testing on July 25 (see Figure 10.) It can be assumed that a monitor in the vicinity of CRM 140.75 LDB would only represent the DO conditions in the discharge from the unit that is operated nearest the LDB. Also, this monitor usually recorded a DO level about 0.2 mg/L less than the DO recorded in the discharge of Unit 1; however, it recorded about the same DO as Unit 3.

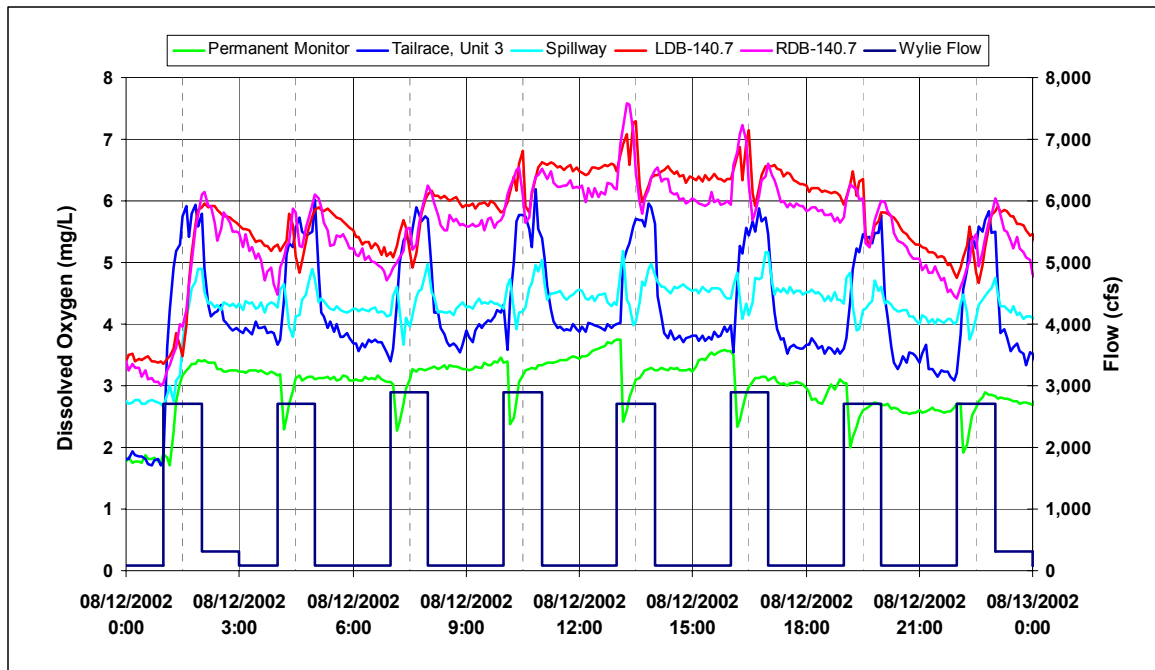
Figure 11: Comparison of DO Measurements, at Various Monitors Locations

These three locations also were evaluated using data collected on August 12 when Unit 3 was the only unit operated. Figure 11 presents a comparison of the DO monitors from these locations, and the results were somewhat similar to those observed during the turbine venting testing with the following exceptions:

It should be noticed in Figure 11 that the permanent monitor recorded lower DO values during the August study similar to how it performed during the week of turbine venting tests (July 23-26). It simply was not representative of DO in the tailrace.

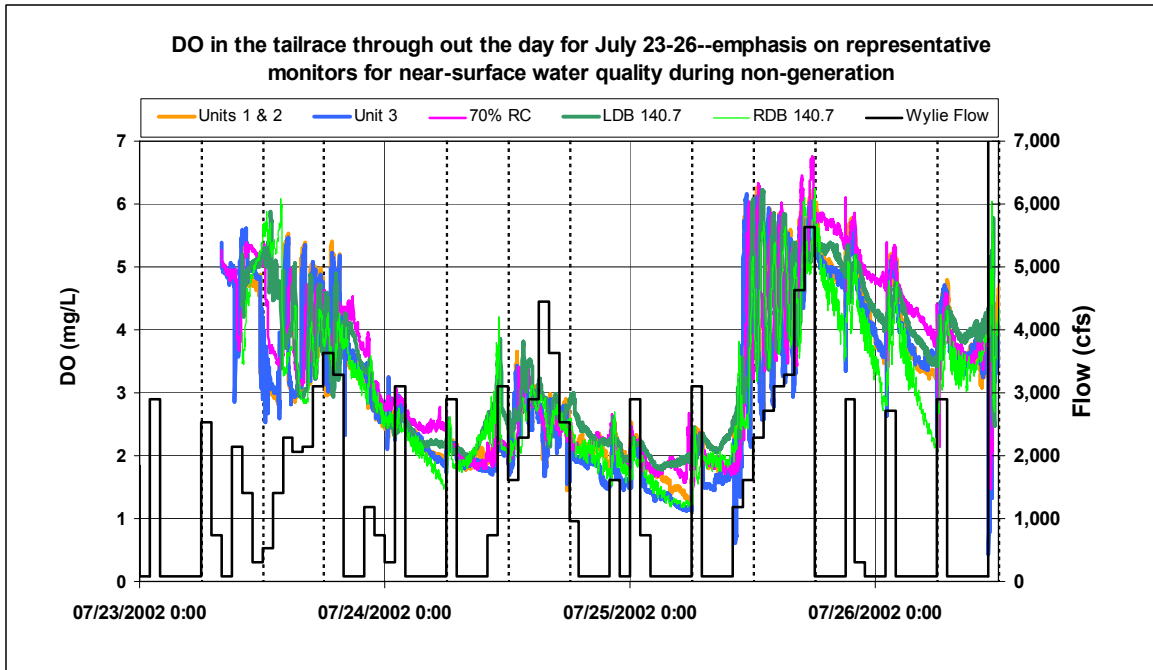
Figure 12: Comparison of DO Monitor Responses During Non-generating Periods

Considerations for DO monitoring during non-generation. Discussion up to this point has focused on monitoring DO during turbine operations. The selection of the location for a tailrace DO monitor should also consider how well water quality conditions are monitored during non-generation. Figure 12 shows how the most promising monitoring locations (CRM 140.75 LDB and RDB and RC 70 %) performed during non-generation periods for the period July 23 through July 26. The results show that either location appears to represent surface water quality in the tailrace area as determined using all the monitors that were located at or near the water surface. However, the monitor at 140.75 RDB tended to record DO levels lower than 140.75 LDB during non-generation.

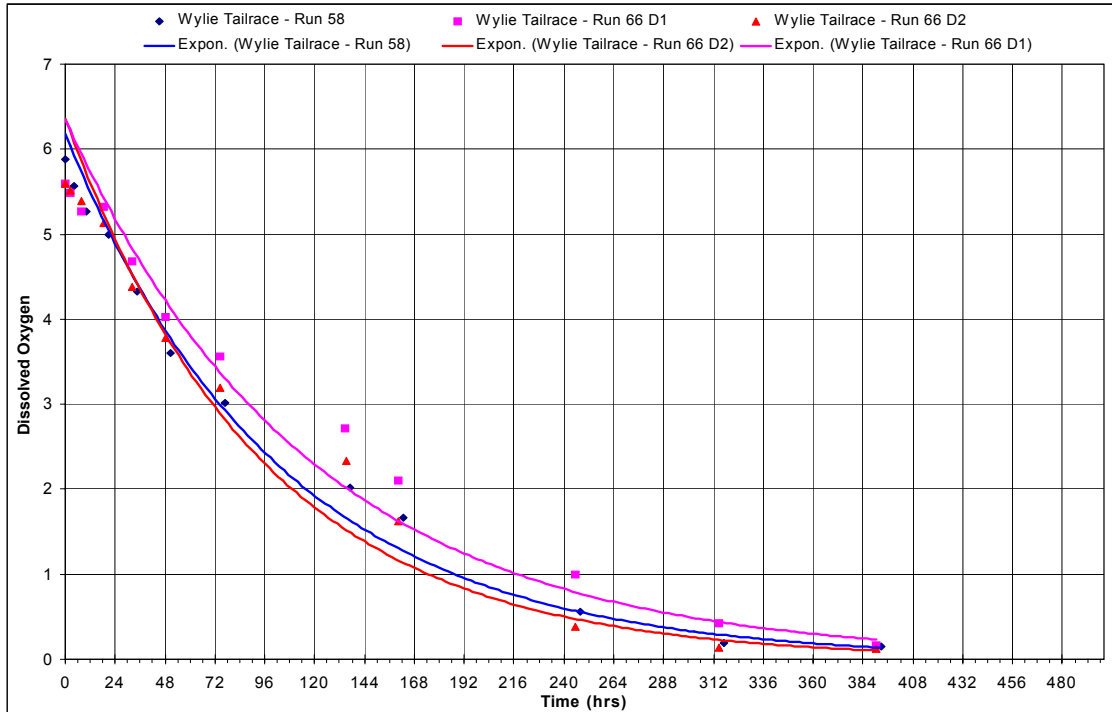
Figure 13: Oxygen Demand in Wylie Tailrace

The nighttime decrease in DO can probably be attributed to DO consumption caused by algal organisms that come from the lake. During the turbine testing, several samples of water were collected from the turbine discharges and the oxygen demand was determined to be at least 6 mg/L over a 10-day period (see Figure 13). Water with this much BOD can exert a high DO demand over a short distance in a river where bacterial growths are attached to the streambed and oxidize organic material over a much shorter period of time (e.g., in hours instead of days.) This drop in DO could also be caused by a deep hole in a portion of the river channel in the vicinity of this location. This hole could result in lower atmospheric reaeration as well as some periodic stratification of the water column when flow is low with associated lower DO readings by the water quality monitors when they are recording DO below the surface of the water.
